## Reducing Flood Risk: stream improvements and water storage

**This case study describes how The Granary Hotel and the Fawsley Estate near Daventry, Northamptonshire, undertook work to improve the flow of a stream running close to the hotel, creating space to store water and reducing flood risk to protect the business.**

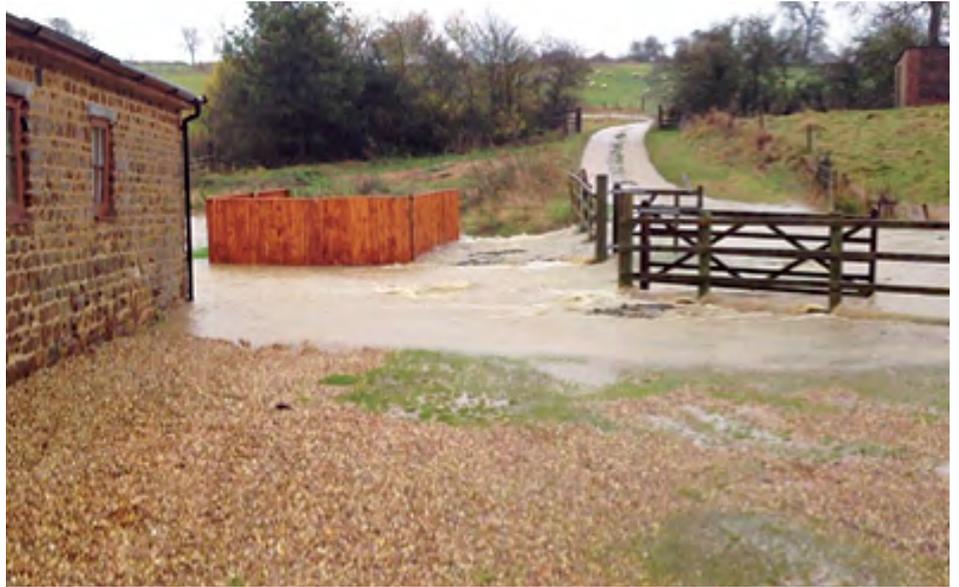
Flooding at The Granary Hotel.

The former flood area is at the corner of the building in the left-hand foreground.

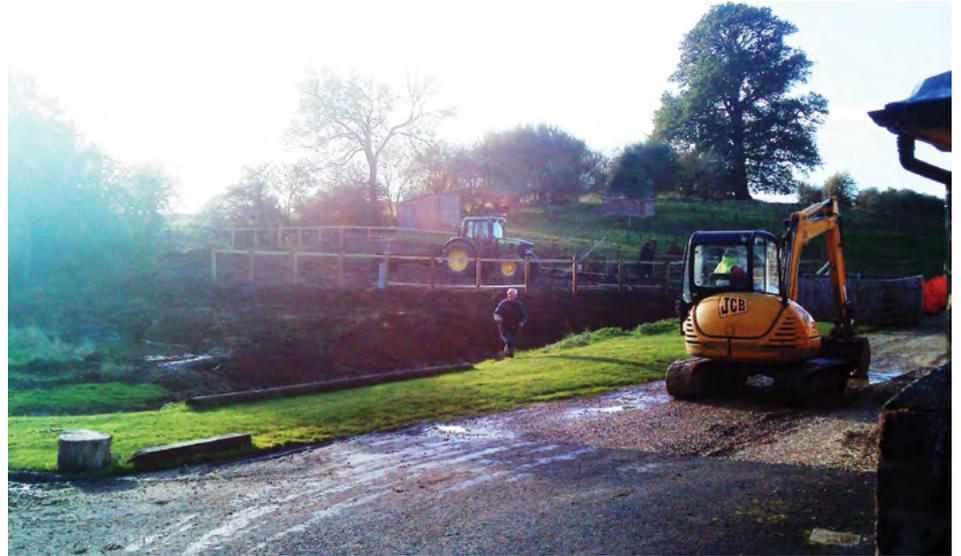
Work underway.

Next, they completely removed the track over the bridge and then the single pipe was replaced by two concrete pipes of the same dimension. They supported the pipes on concrete and constructed a concrete block wall at either side to the level of the finished track, and finally filled the track area with graded road stone and small top dressing similar to the grey stone farm track.

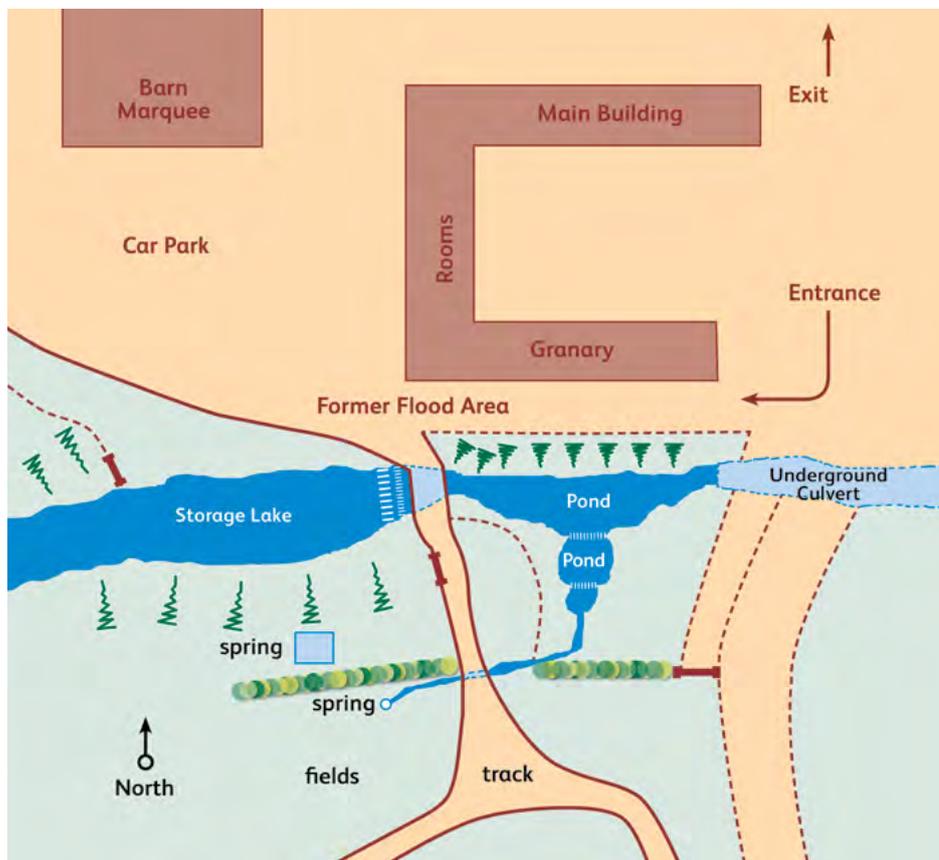
This diagram shows the hotel buildings in relation to the stream, and the location of the former flood area. It shows the features created to store water, namely the storage lake and the ponds. The stream flows from west to east.

The Estate provided its own staff and machinery to solve the problem. They first dug out a small “storage” lake to the west of the bridge and adjacent to the car park. This lake is approximately 50 yards in length and up to 8 yards wide. At the east end of the lake a large tree trunk was laid across the width of the stream, creating a waterfall before the stream goes under the bridge. This has the effect of deepening the water up-stream of the tree trunk by 3 feet and enables the water to “back up” the valley or gorge at times of heavy rain, instead of flooding the adjacent area.

On the east side of the bridge the estate contractor created an attractive pond to protect the culvert with a water storage area. This was further enhanced by a two level pond entering the stream from the south. The reason for this was that a tiny spring in the next field had created a small water

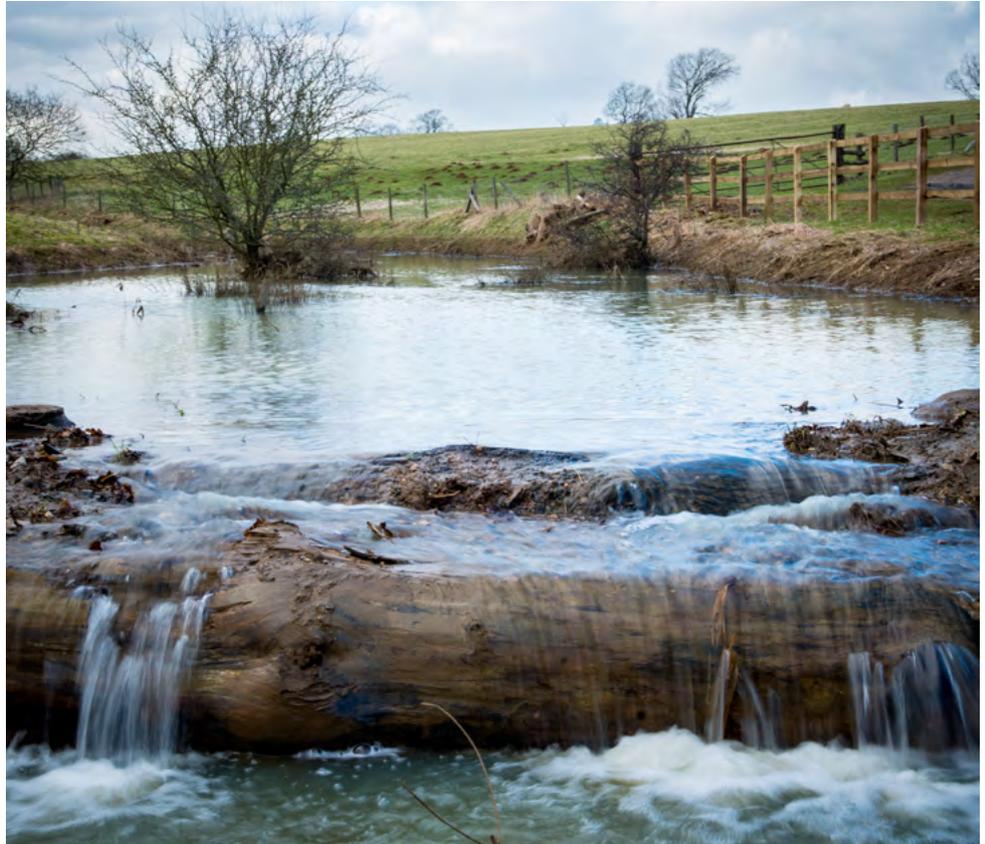
**A large tree trunk deepens the water up-stream, and allows the water to “back up” the valley at times of heavy rain**
